Manhole Inspection Summary

Manhole # S31SS_022MH

Insp Date: **5/2/07 12:31 PM**

Location Address: **215 LORAIN AVE**

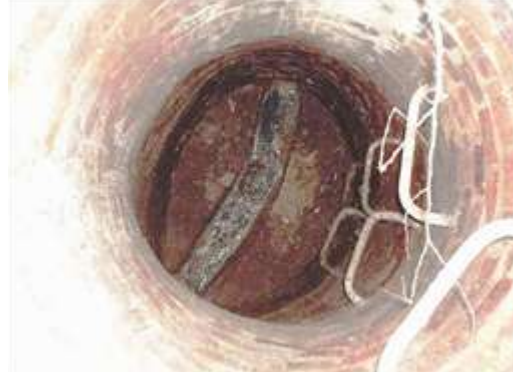
Top View

Corroded steps. Evidence of surcharge - Bench debris. Channel debris.

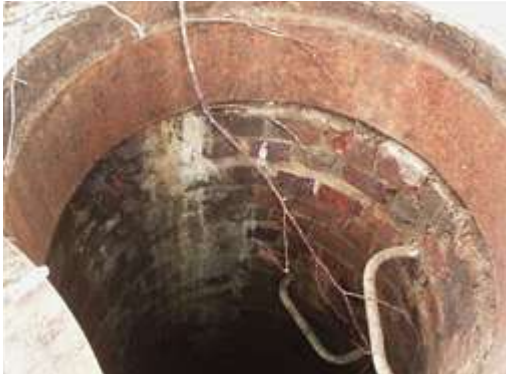
Defect

Frame leaks. Adjustment deterioration and infiltration. Corbel and Barrel infiltration - other side.

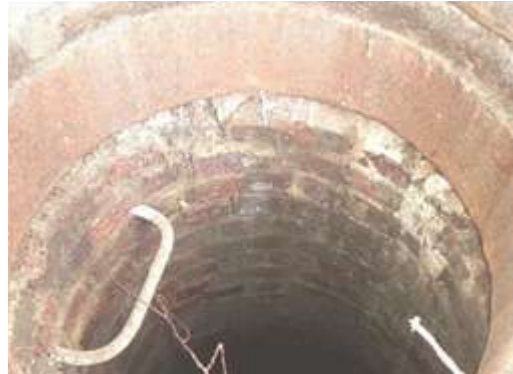
Defect

Frame leaks. Adjustment deterioration, root intrusion and infiltration. Corbel and Barrel infiltration.

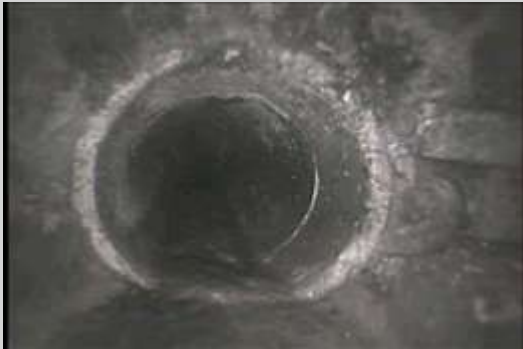
8 in. Circular Gravity Sewer Pipe Out @ 12 O'Clock

Rod and Bar (Angled)

Infiltration: **None** Pipe Seal Cond: **Unknown**

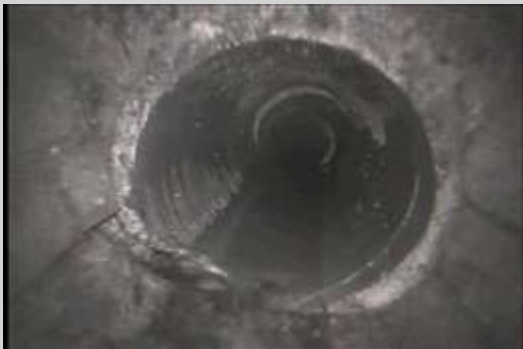
8 in. Circular Gravity Sewer Pipe In @ 7 O'Clock

Rod and Bar (Angled)

Infiltration: **None** Pipe Seal Cond: **Unknown**
